## **Report on Air Conditioning Unit Maintenance in Baldwin Square 1**

Michael Oelke 6 Feb 2005

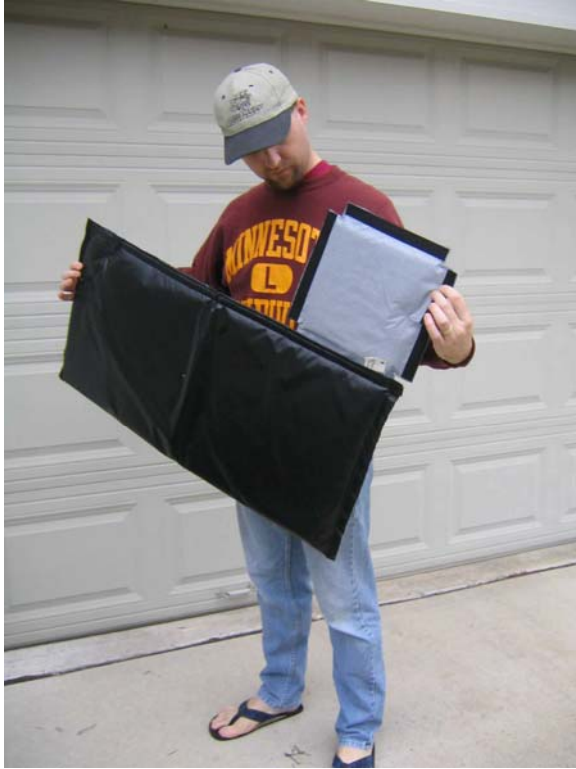
The blanket is a simple blanket with Velcro closures. It folds in to a box with the bottom open and a few slots on one long edge through which the Freon lines can pass. It installs in minutes. Pictures of blanket before and after installation are below.

Photo captions clockwise from upper left:  
1) Blanket flat layout before folding in to shape  
2) Assembled blanket  
3) Taking measurements with SPL meter  
4) Blanket installed over compressor

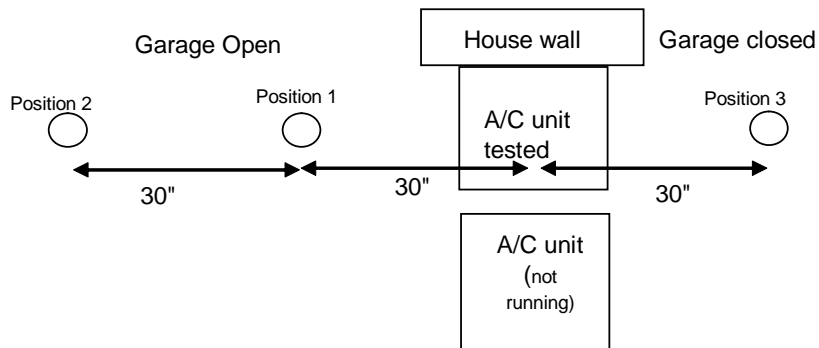
Layout of test setup

Measurements were taken with a SPL meter on a tripod, ~4ft above ground. Measurements taken from thr positions.

Position 1	Position2	Position 3
Before blanket	A weighted	71	67	72
	C weighted	74	69	73
Blanket installed	A weighted	68	64	67
	C weighted	73	68	70
Difference	A weighted	3	3	5
	C weighted	1	1	3

So the drop in acoustic level is about 3 db
